NON-SLIP SAFETY SYSTEM SUPERIOR TO SAFETY 'STRIPS'

Regional Hospital - British Columbia, Canada.

Slippery quarry tile floor.

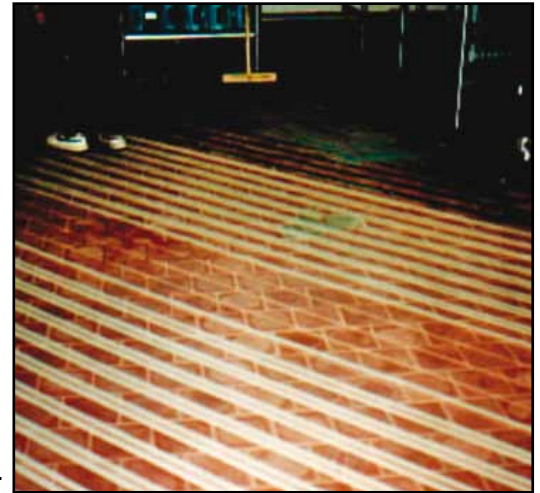
1. Preparation underway using a straight edge template and a saw fitted with a double half inch masonry cutting blade and vacuum. This involved a double pass to achieve the desired 1-inch prepared strip. Masking tape was applied to the edges.
2. Completed application.

Application was carried out in accordance with Belzona Know-How System Leaflet FPA-8.
