DISH WASHING ROOM - SAFER WITH BELZONA SYSTEM

Extended Care Facility - British Columbia, Canada.

Safety system required in care centre dishwashing room. Total area completed approximately 700 square feet.

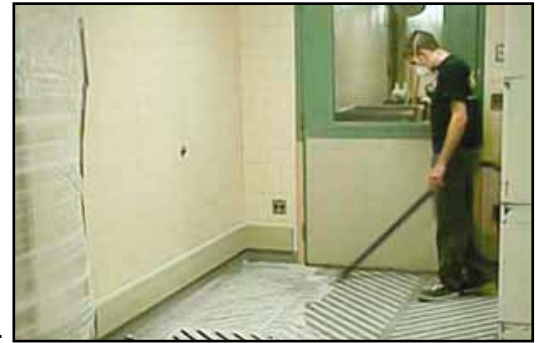
1. Preparation underway using a special silicon carbide grinding tool and template
2. Hospital opted for various different 'chevron' style patterns to help break up the areas
3. Another view of application with a different pattern

Application was carried out in accordance with Belzona Know-How System Leaflet FPA-8.
