WET FLOORS MADE SAFE WITH BELZONA

Hospital - Victoria, British Columbia, Canada

Non-slip safety system required on quarry tiled dish washroom and food preparation area floors which were constantly wet.

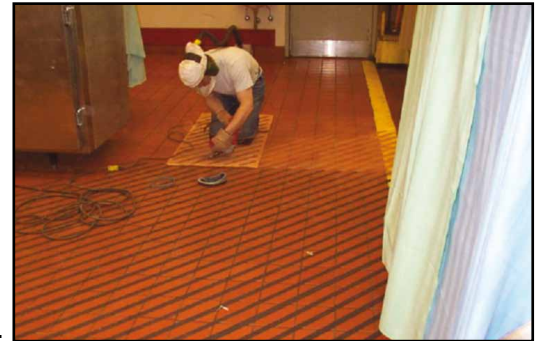
1. Preparation underway using special silicon carbide grinding tool and template
2. Masking completed and application of grip system in progress
3. View of completed section of food prep area
4. View of completed wash area

Application was carried out in accordance with Belzona Know-How System Leaflet FPA-8.
