## BELZONA® 1521 PROTECTS HYDROCYCLONE

North Sea Oil Producer

April 2004

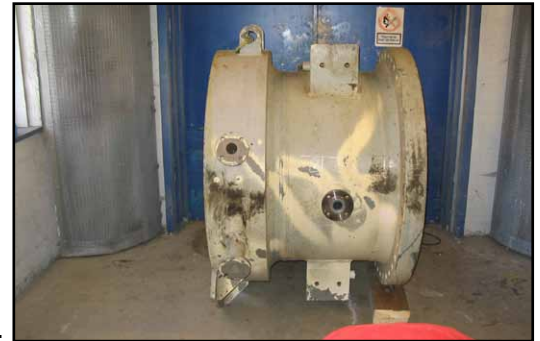
Failure of the existing glass flake lining had led to corrosion of the hydrocyclone body, which operates at elevated temperature.

1. Hydrocyclone body
2. Application of Belzona® 1521 in progress
3. Completed application

Belzona® 1521 was applied to the hydro cyclone vessel body using heated airless spray following grit-blasting. Nozzles were coated internally by brush.
