BELZONA® 1521 PROTECTS OIL/GAS/ WATER SEPARATOR

North Sea Oil & Gas Producer

Corrosion of oil / gas / water separator.

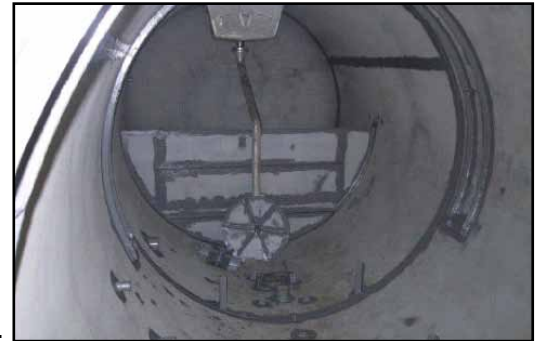
1. Stripe coating of welds, nozzles and brackets
2. Completed upper half of vessel
3. Completed weir area and brackets

Following grit blasting, stripe coating was completed using Belzona® 1391 for all nozzles, welds and brackets. Following reblasting Belzona® 1521 was applied using heated airless spray.
