LEAKY ROOF IS NO PROBLEM FOR BELZONA

Factory roof - Texas U.S.A.

Sections of roof gutters

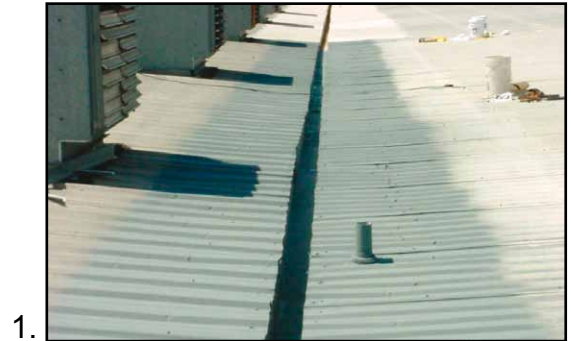
1. Conditioned and coated
2. Roof gutters
3. View of roof area
4. Another view of the gutters

Areas were cleaned, conditioned and two coats of Belzona® 3111 were brushed on. The total area protected with Belzona® 3111 was 8,000 sq. ft.
