BELZONA ROUTINE CYLINDER SALVAGE OF ENGINE BLOCK

River cruiser in Egypt

Diesel engine block from large river cruise ship

Cavitation damage in water jacket

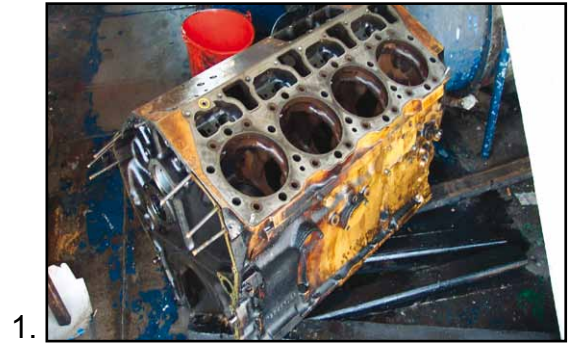
1. The engine block
2. Location of damage
3. Close up of the cavitation
4. Completed application

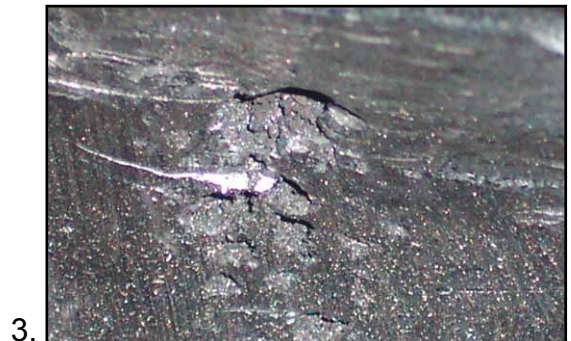
This is a routine repair on engine blocks as cavitation is a common problem in this area of the engine. Belzona provides a quick effective repair without heat and provides good cavitation resistance in the hot coolant.
