BELZONA REPAIR TO SHAFT AND KEYWAY OF DIESEL ENGINE TEST DYNAMOMETER

Engine repair facility in Egypt

April 2003

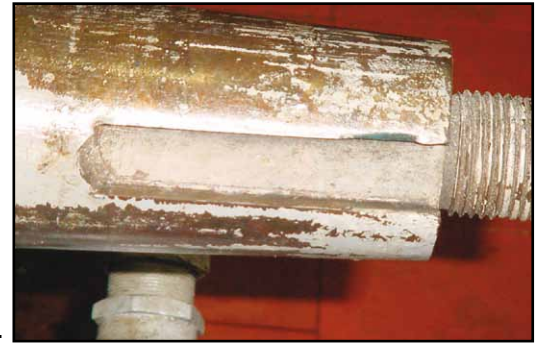
The tapered coupling and keyway were damaged on the main power input shaft.

1. The damaged shaft and keyway
2. Application of Belzona® 1111 to the former
3. Former being clamped onto the shaft
4. Both ends of shaft rebuilt
