BELZONA SOLVES ACID ATTACK

Chemical Plant, Cheshire UK

Sump in chemical plant

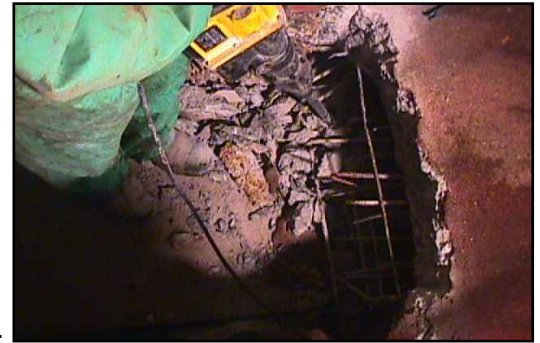
1.

Hydrochloric acid was seeping into a nearby water course. The problem was tracked down to a sump where hydrochloric acid had eaten through the concrete.

After the original insert box was removed the large hole that had been made by the acid eating through the concrete, leaving only remnants of the reinforcing bar was discovered. With the use of heaters, the hole was repaired and sump protected with Belzona within the allowed three-day time frame. Still performing as expected - problem totally solved.

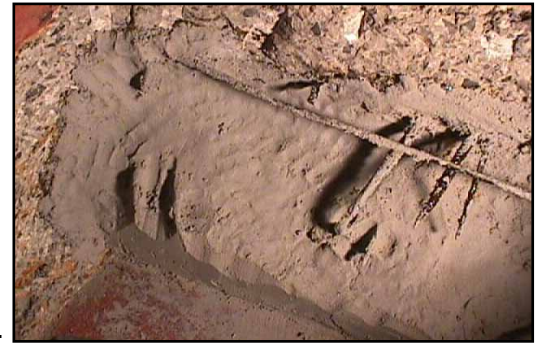
1. The extent of the problem.
2. Belzona® fills the hole.
3. Sump rebuilt.
4. Finished application.
