LIFTING DEVICE FOR FENDER

Keppel Shipyard, Philippines

March 2005

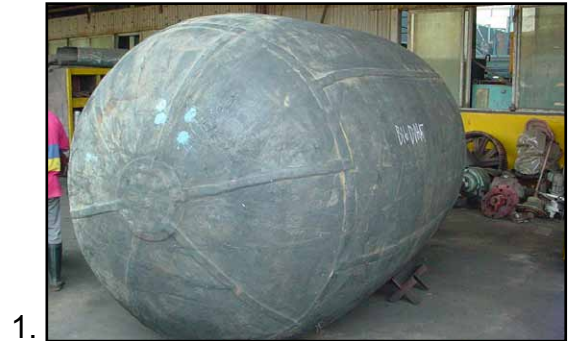
1. Fender without lifting device.
2. A 12" diameter plate is prepared with lifting hook.
3. Surface preparation for the fender.
4. Finished application - metal lifting device is attached to the fender.
