BELZONA SEALS LEAKING TRANSFORMER FLANGES

Electricity Supplier, British Columbia, Canada

Electricity Transformer Flanges

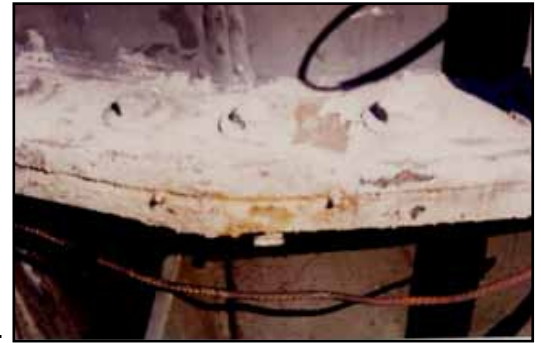
Oil was leaking out between the flanges.

1. View of oil covered flange.
2. Flanges degreased and blasted to provide a good rough surface profile.
3. Application in progress with bolts being sealed first.
4. Completed application.
