BELZONA SEALS SF₆ LEAKS AT HYDROELECTRIC POWER STATION

Hydroelectric Power Plant, British Columbia, Canada

SF₆ gas pipe

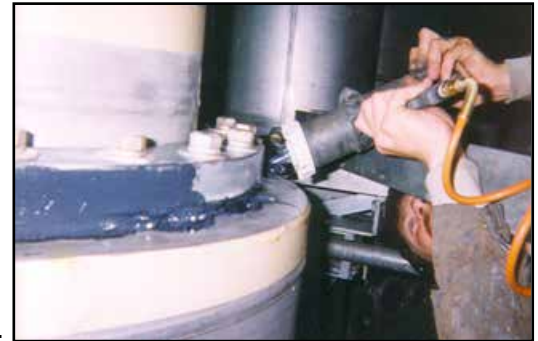
1. Belzona® 2211 was injected into the gap between the 2 flanges.
2. Application shown in #1 completed.
3. Another flange sealed.

SF₆ gas was leaking from the joints of the system requiring regular refilling.

Belzona® 2211 (MP Hi-Build Elastomer)
