BELZONA REPAIR OF RUBBER IMPELLER

Chemical Plant, Italy

Rubber covered pump impeller.

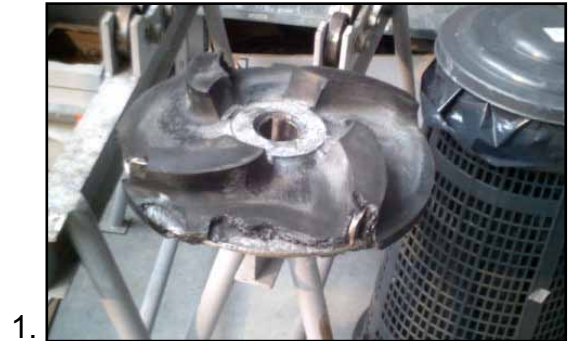
Whilst casing had little damage, the impeller vanes were very badly damaged and needed rebuilding.

1. The damaged impeller
2. Aluminum formers in place
3. Casting underway
4. The finished impeller
