BELZONA SAVES PLANT \$400,000 PER WEEK

Mineral Processing Plant in South Texas

Nov/Dec 2006

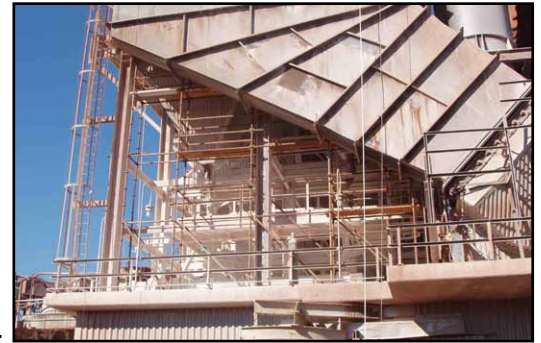
The steel ductwork had become corroded from salt water spray and NAOH mist. Vibrations from operations caused sections to become disbonded from the framework.

1. Ductwork before work commenced
2. Close up of framework showing loose connections
3. Another view of framework showing loose connections
4. Finished application

Application carried out in accordance with Belzona Know-How System Leaflet TCC-5. Belzona® 1111 and 1121 were used to bond loose metal to framework when system was out of service and cool. System was then brought up to operating temperature and Belzona® 5851 was used to coat the repaired areas and the entire surface to prevent further corrosion.
