BELZONA BECOMES STANDARD REPAIR ON BOTTLE FILLING EQUIPMENT

Soft Drink Bottler, Michigan

Cast iron bottling table for soft drinks

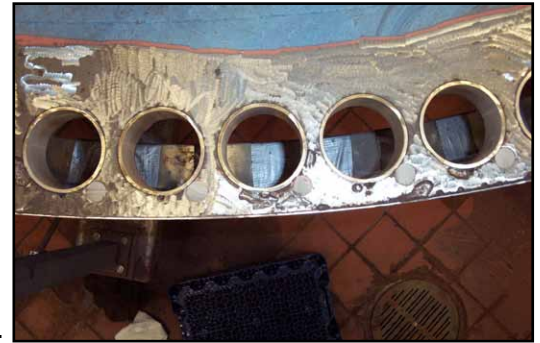
1. Bushings installed and table prepared. Note deep corrosion pitting.
2. Surface restoration with Belzona® 4301.
3. Surface coated with Belzona® 4311.
4. Stainless steel plates seated in Belzona for full support and corrosion protection.

Tooling pockets are re-bored and bushings installed. Where the pockets are corroded excessively and bushings can't be shrunk fit they are installed in Belzona® 4301 as per Belzona Know-How System Leaflet ENC-3b. The surface is then repaired with Belzona® 4301 and coated with Belzona® 4311 as per System leaflets TCC-3 & TCC-5. Stainless plates are installed and seated in the wet Belzona® 4311 for permanent protection from future spillage.
