BELZONA ELASTOMERS IDEAL FOR HIGHWAY REPAIRS

State Agency / South Texas

Summer of 2006

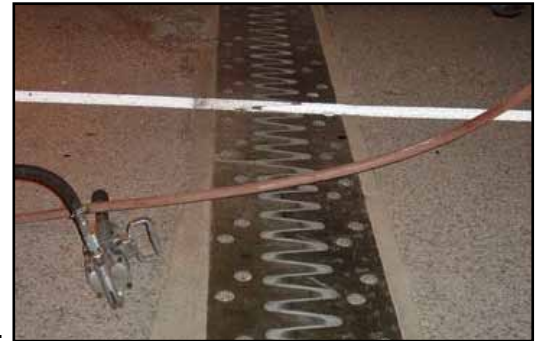
1. Large highway expansion joint
2. Grate over sealant removed
3. Torn rubber was cleaned, roughened up and conditioned
4. Finished repair
