## BELZONA ELASTOMERS SEAL SF6 GAS LEAKS AT HYDROELECTRIC FACILITY

Hydroelectric Facility, BC

Leaking joints Gas Insulated Switchgear (GIS)

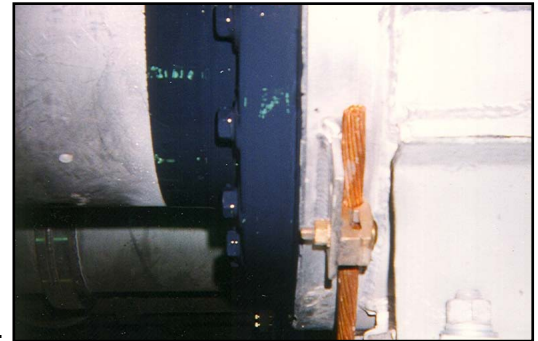
1. Belzona® 2211 MP Hi-Build in the process of being injected into the gap between the two flanges
2. Another variation of a similar application
3. Another flange sealed

Application was carried out in accordance with Belzona Know-How System Leaflet GSS-4. Pinholes in welds were coated with Belzona® 1321. Flanged joints were sealed with Elastomer using a combination of brush application and injection.
