27 YEAR OLD BELZONA BUILDING REPAIR

Department of Education, Newcastle, UK

College building balcony edges and rail supports.

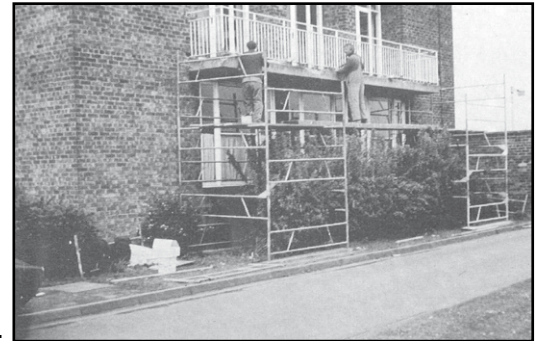
1. The original repair being carried out in 1981
2. A section of the original repair in 1981
3. The balcony in February 2008
4. The same area as shown in picture 2 after 27 years

Application was carried out in accordance with Belzona Know-How System Leaflet FPA-10. Corroded tubular rail supports cut away and steel bars glued into remaining tubular supports with Belzona® 1111. Spalled concrete then rebuilt encapsulating the new steel supports.

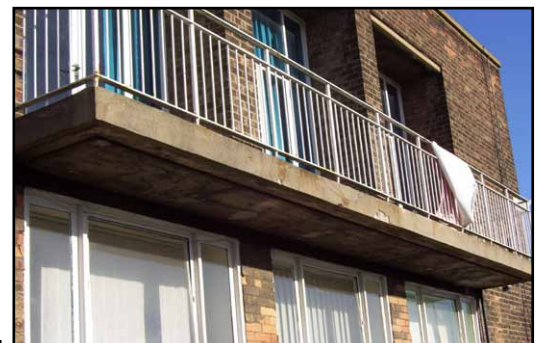
3.

As shown in the photographs, the Belzona repair is still in perfect condition in February 2008, over 27 years after the original application.
