BELZONA COATS STACK WHILST IN SERVICE

North American Galvanizing

Vent stack for hot gases operating between 300 & 550°F (150 & 280°C) internal temperature.

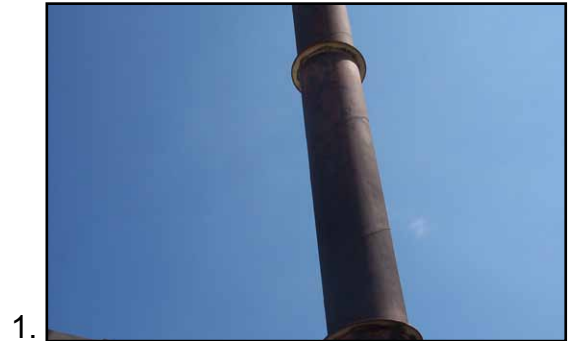
1. Original chimney
2. Test strip - top portion, bottom - burned portion
3. Final application - 4 months later
