BELZONA PROVIDES LONG TERM PROTECTION AGAINST UNDER FLOOR CORROSION

Petrochemical Plant - UK

Carbon steel Paraxylene storage tank.

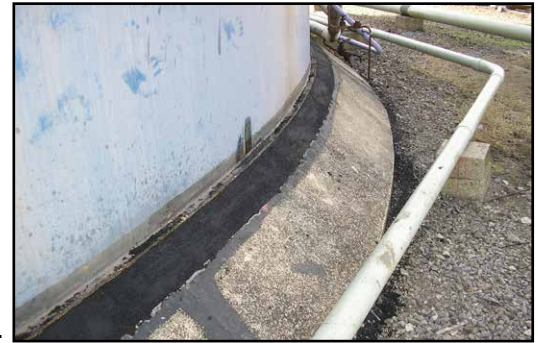
As a result of water ingress through the mastic type seal, under floor corrosion had occurred to an extent that the floor needed replacing. The customer was looking for a longer lasting, more effective base seal to satisfy government agency requirements.

1. Before application of the Belzona system after new floor fitted
2. Application in progress
3. Application complete
4. Completed application over 2 years later
