## BELZONA SMOOTHS OUT DAIRY RAMP

Dairy, Telford, UK

2007

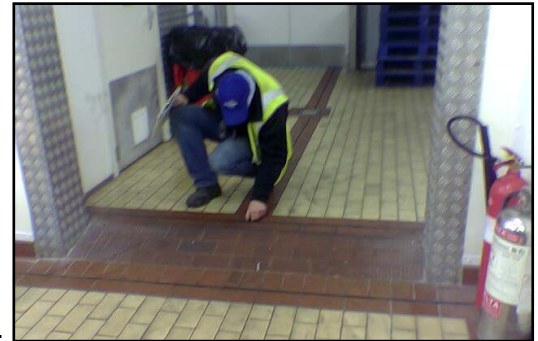
The slope was causing product being transferred from section to section by electric hand truck to be both unstable on the pallets and a safety hazard when travelling down the slope.

1. Inspection of ramp prior to work
2. Application of Conditioner prior to Belzona® 4111
3. Application of Belzona® 4111 begins
4. The finished ramp

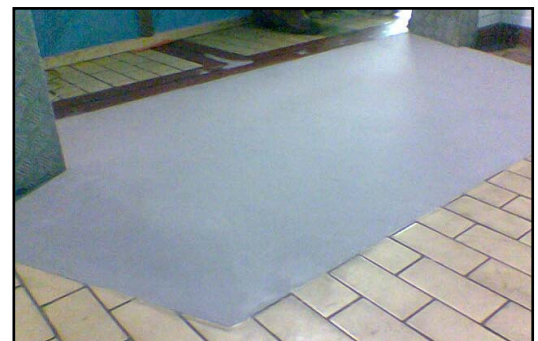
4.

The Factory works non-stop and the safety issue could not wait for a shutdown. The window to work in was very short, 36 hours maximum. Client chose Belzona on grounds of technical support ensuring application completed in tight time frame. The ramp looks as good as new more than 12 months later.
