BELZONA SHAFT REPAIR ON SUBMERSIBLE PUMP

Pump refurbishment Co, Wales, UK

Bore hole pump

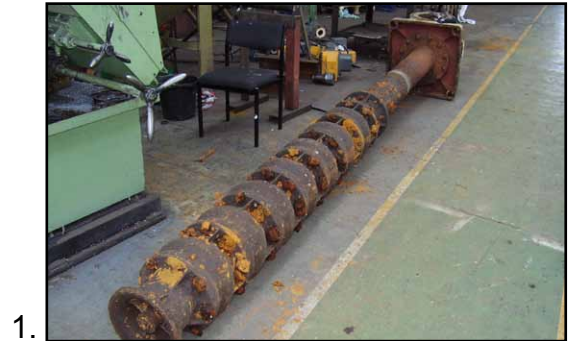
1. Pump unit complete
2. Shaft damage/wear
3. Machining following Belzona® 1131 application
4. Completed repair

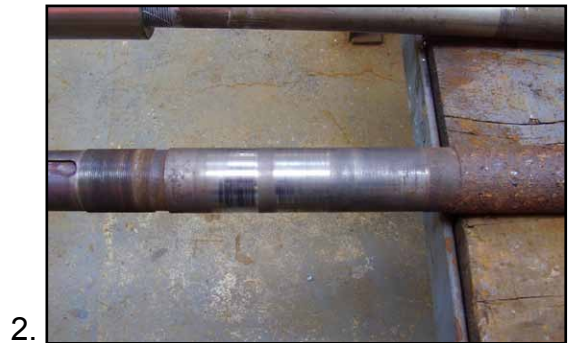
Damage to bearing surface caused by constant motion of phosphor bronze bushing

Belzona® 1131 (Bearing Metal)

Application was carried out in accordance with Belzona Know-How System Leaflet MPT-9.
