BELZONA PROTECTS CHEMICAL CONTAINMENT AREAS

Coal Power Plant, Galicia, Spain

Four chemical containments for polyester tanks filled with sodium hypochlorite

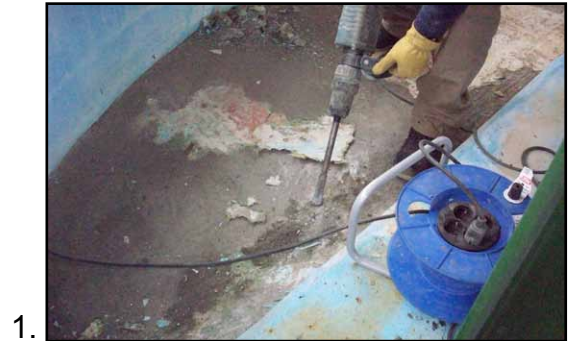
1. Removing the old coating
2. Blasting the surface to be coated
3. Applying the second layer of Belzona® 4311 over the first coat
4. One of the containment areas after one month
