BELZONA REBUILDS SHAFT & KEYWAY ON JAW CRUSHER

Jaw crusher used to process minerals used in refractory manufacture.

Shaft and keyway worn and damaged

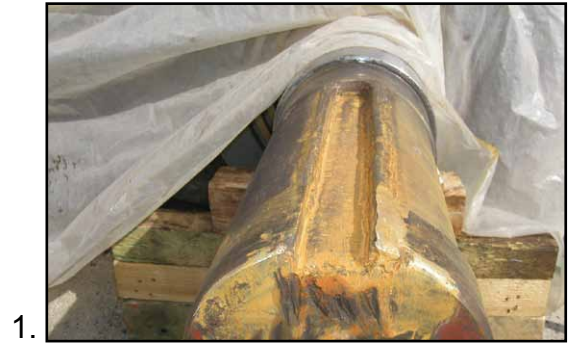
1. Damaged shaft
2. Milling the keyway
3. Turning the Belzona® 1111 rebuilt shaft
4. Shaft ready to transport back to customer
