## BELZONA REPAIR TO PIVOT PINS OF MILL

Ceramic tile manufacturer, Slovakia

The 70 ton mill is crushing raw materials for the production of tiling and facings.

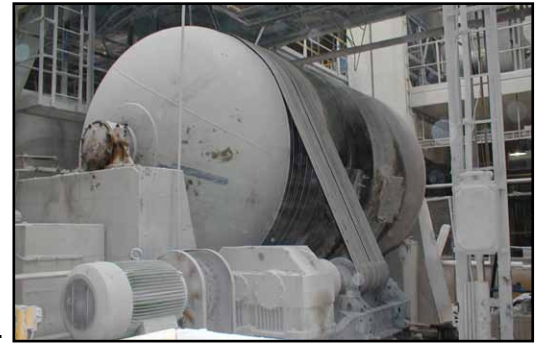
1. An overall view on the mill
2. An example of the excessive damage of the pins
3. Belzona® 1111 ready to be machined
4. The pivot pin prepared for operation

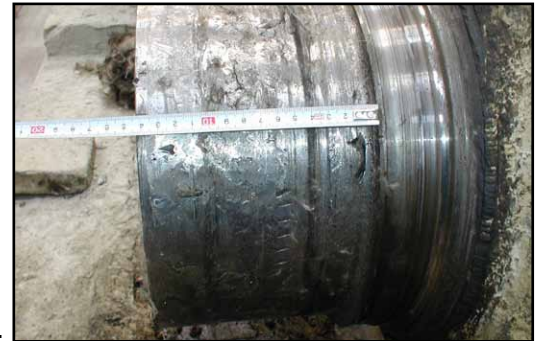
2.

The two pivot pins supporting the crusher are damaged due to loading and working environment.

Application was carried out in accordance with Belzona Know-How System Leaflet MPT-1. Hand portable lathe was used to machine the pivot pins.
