## BELZONA REPAIRS HEAVY DUTY SHAFT

Rock Quarry & Cement Plant

Obsolete rock crusher from the 1950s. It has 300lb hammers on it. Used in the cement plants own quarry.

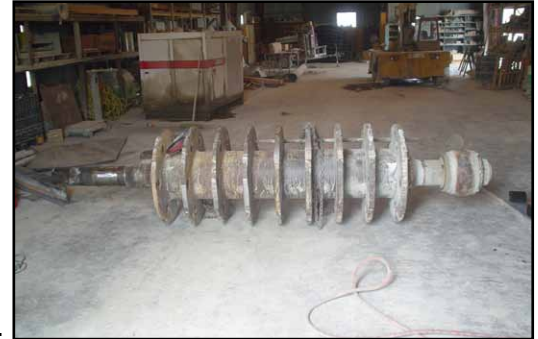
A bearing spun on the rock crusher at the cement plants quarry. Without the crusher back in service the entire quarry and cement plant would shut down.

1. Rock crusher
2. Belzona® 1111 in split mold
3. Sanding shaft to size
4. Shaft ready to go to work
