SANDSTONE MULLION REPAIRS WITH BELZONA

Private Householder, Scotland

July 2003

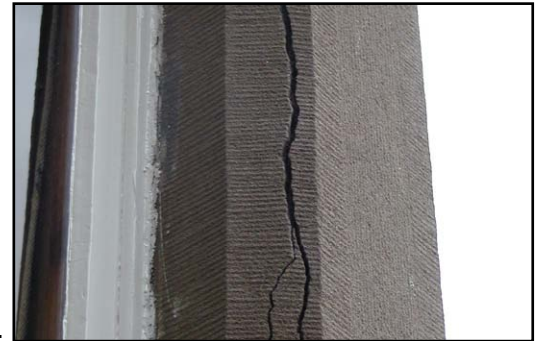
The cracks were getting worse due to frost damage in the winter months and previous attempts at concrete repairs had failed at the bond lines.

1. The problem. Note the grooving of the sandstone.
2. Belzona® 4141 being applied as a skim coat.
3. Finished application.
4. Inspected December 2007.

Application was carried out in accordance with Belzona Know-How System Leaflet WPA-4. The cracks were opened out and filled prior to the whole mullion being skimmed with Belzona® 4141 tinted to match the colour. The original grooving on the stone was replicated in the Belzona® 4141.
