COMPETITOR FAILURE BRINGS BELZONA BACK

Power Plant, Birmingham, Alabama U.S.A.

Sulfuric acid containment area. Failed coating allowed chemical leakage into the environment.

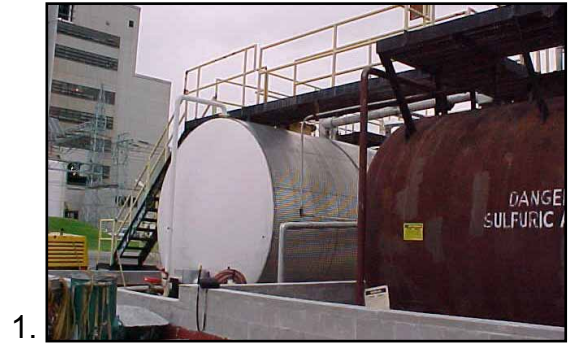
1. The acid and caustic containment area
2. Concrete damage
3. Coated containment area
4. Belzona® 4311 on the acid tank after 12 years

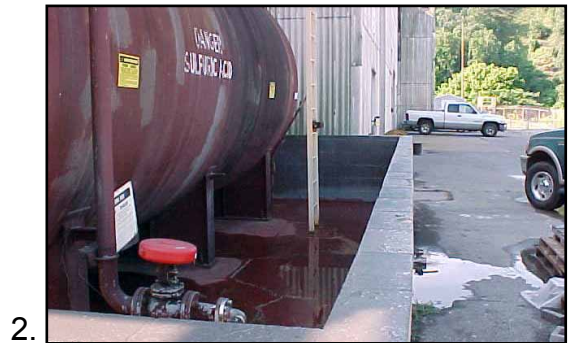
Competitor coating failed within two years. Belzona was asked to coat the concrete since Belzona® 4311 had been on the sulfuric acid tank itself for almost 12 years.

Application was carried out in accordance with Belzona Know-How System Leaflets TCC-9 and TCC-15. Damaged concrete was repaired with Belzona® 4111. Coated the acid side of the containment area with Belzona® 4311 and the caustic side with Belzona® 5811.

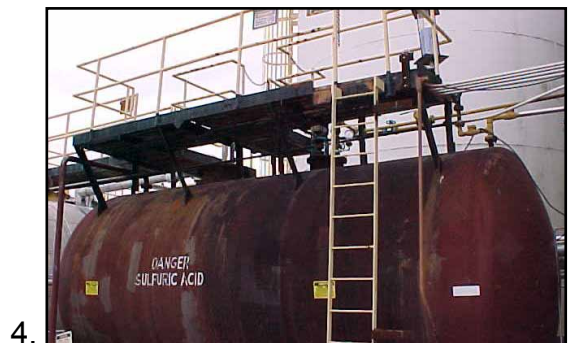
Belzona® 4311 was applied to the acid tank in 1988 and 12 years later was still perfect other than a little staining. The client had used a cheap coating in containment area first and after it failed decided to spend a little more money to make it last a long time. 8 years later and minor repairs are all that are needed on the Belzona.
