BELZONA STANDS THE TEST OF TIME

Petrochemical Plant, Louisiana U.S.A.

Rebuild and protect the tube sheets on the faces of chiller. Also returned five years later for customer to inspect and to coat the channel box and baffle.

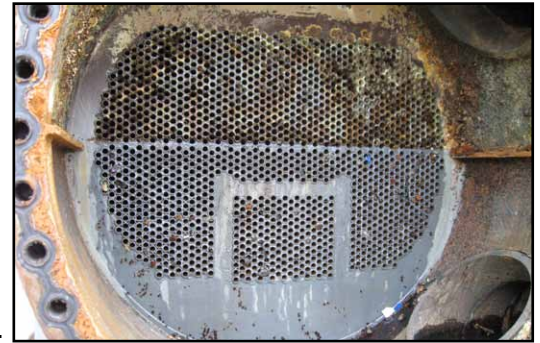
Tube sheet was suffering from bi-metallic corrosion and channel box was suffering from erosion/corrosion.

1. Tube sheet revisited after 5 years
2. Existing Belzona repaired blasted and channel box coated for first time
3. Fully restored tube sheet with second application of Belzona
4. Rear of chiller shown fully corked and coated, waiting for corks to be removed
