BELZONA® 4181 SOLVES NEUTRALIZATION PROBLEM

Chemical Plant, North Alabama U.S.A.

Secondary containment area for 98% Sulfuric acid

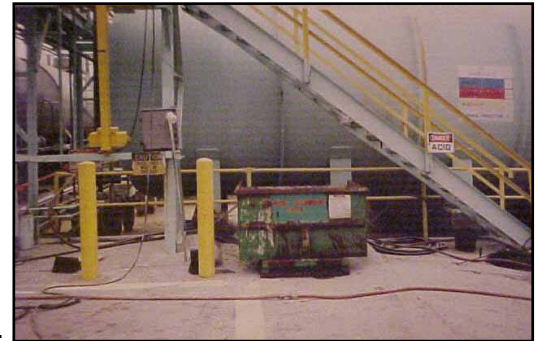
1. Overview of the sulfuric acid containment area
2. Deteriorated coating after the caustic was added to the acid spill
3. New concrete poured and pedestals coated with Belzona® 4311
4. Finished project with Belzona® 4181 and perfect after 8 years

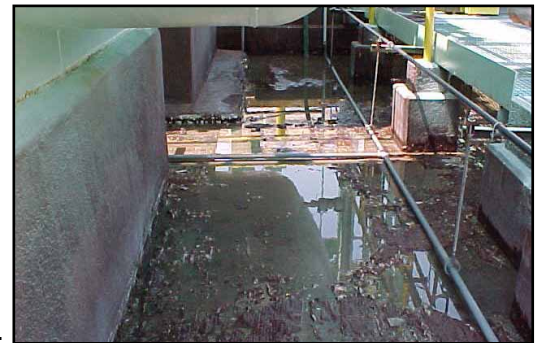
2.

Spill of 98% sulfuric acid was neutralized with caustic. The exotherm badly damaged the coating applied 2 years previous.
