BELZONA® 4111 AFTER 15 YEARS

Kiel Center in 1993, Scott Trade Center Today, St. Louis, Missouri U.S.A.

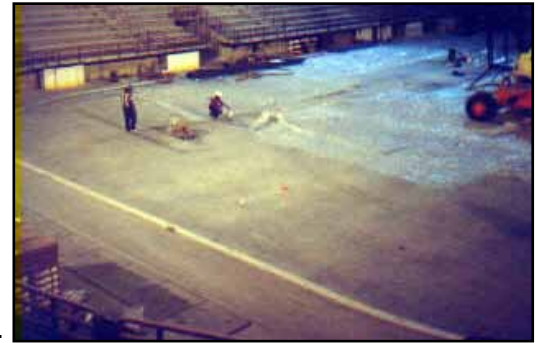
1. Overall view of the floor in 1993
2. Anchor points being chipped out
3. Starting the repairs
4. Typical Belzona anchor 2008
