## BELZONA REPAIRS AND PROTECTS WATER TREATMENT PLANT

Nuclear Power Plant, Lancashire - UK

Sulphuric acid containment bund around tank and pipework  
Acid dilution bund.  
Sulphuric acid transfer channel. All located in the demineralisation (water-treatment) plant of the power station.

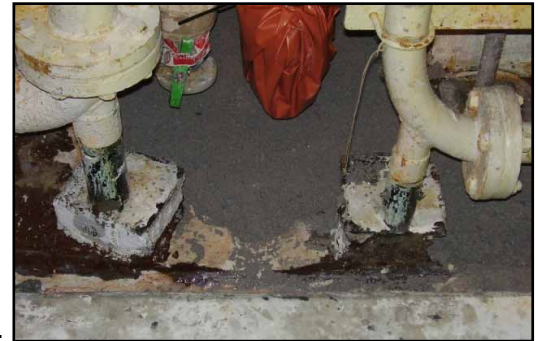
1. Substrate rebuilt using Belzona® 4131
2. Protection provided by Belzona® 4311 coating
3. Channels rebuilt and lined with Belzona® 4181
4. Completed application back in service
