BELZONA® 5851 HELPS AVOIDS SHUT DOWN

Production Rig North Sea

May 2007

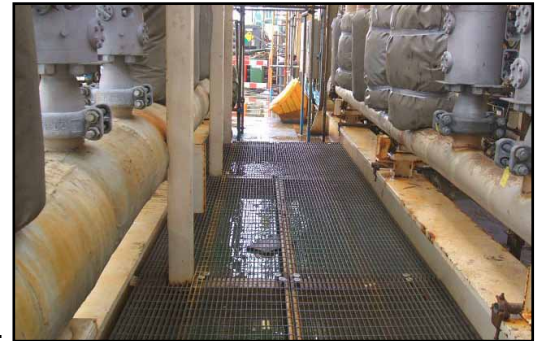
Weathering of the original paint system on high temperature Duplex lines.

The loss of the original paint system exposed the pipe work to a risk of stress corrosion cracking whenever the fire protection Deluge system were tested.

1. Manifold showing weathering of paintwork
2. Belzona® 5851 applied to exposed pipe work
3. Belzona® 5851 applied to exposed pipe work
4. Belzona® 5851 applied to the manifold

Application carried out in accordance with modified Belzona Know-How System Leaflet VPF-2. The pipework was wet-blasted to remove poorly adhering paintwork and any salts from the substrate.
