## SHAFT JOURNAL OF STONE CRUSHER REPAIRED WITH BELZONA

Main shaft of primary stone crusher

Shaft damaged by seized bearing.

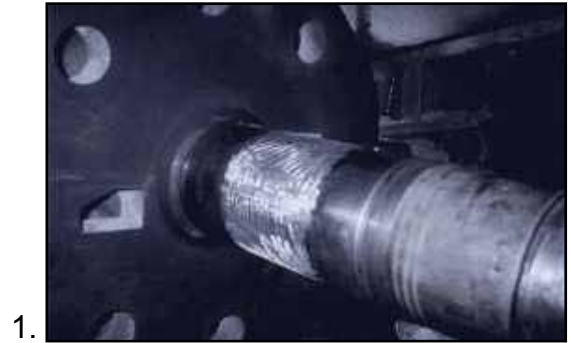
1. Preparing shaft surface
2. Forming with manufactured pipe clamp
3. View of repair with former removed
