## CONVENIENT BELZONA CONVEYOR BELT REPAIR

Power Industry, Bulgaria

Previously vulcanized joints in coal conveyor utilizing Tip Top.

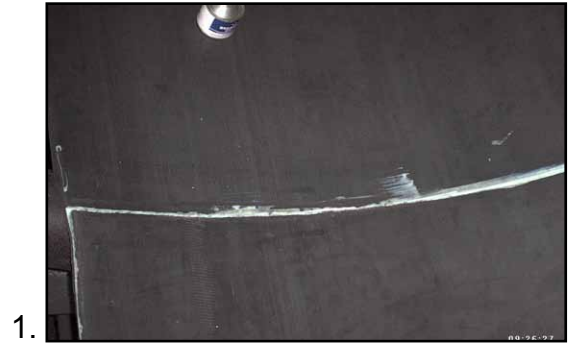
Joint failing due to moisture.

1. Original joint
2. Repair area masked off and conditioned
3. Completed application
