## BUTTERFLY VALVE REFURBISHED WITH BELZONA

Water supply station, Egypt

Butterfly valve in water distribution system.

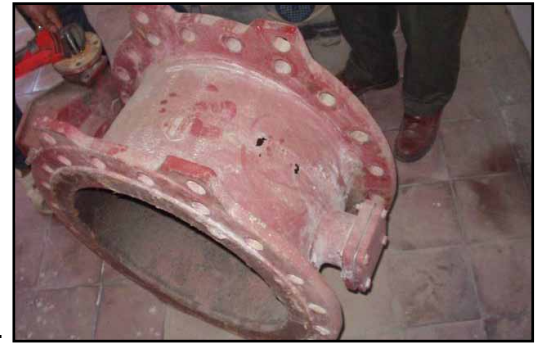
Body badly corroded sand holed in places. In addition rubber seal on valve disc completely deteriorated.

1. General view of the valve
2. The worn out rubber seal
3. Rubber seal was perfectly cast
4. Valve rebuilt and coated, application complete
