## BELZONA PROTECTS CLARIFIER

Chemical Plant, Italy

Concrete structure of clarifier.

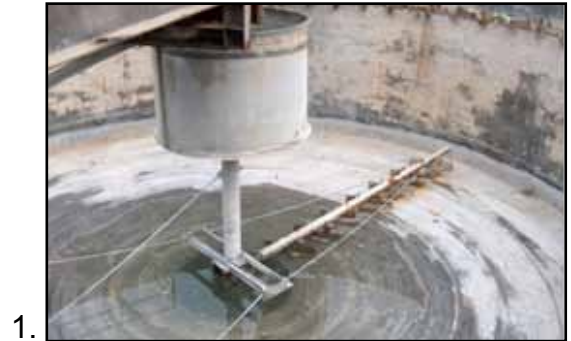
Concrete damaged by erosion and abrasion led to underground leakages with contaminated water.

1. Before Belzona
2. Application of Belzona® 4111
3. Application of Belzona® 5811
4. Completed application
