## BELZONA REPAIR OF CONVEYOR BELT

Power plant, Bulgaria

5 km conveyor belt for transporting coal to the power plant

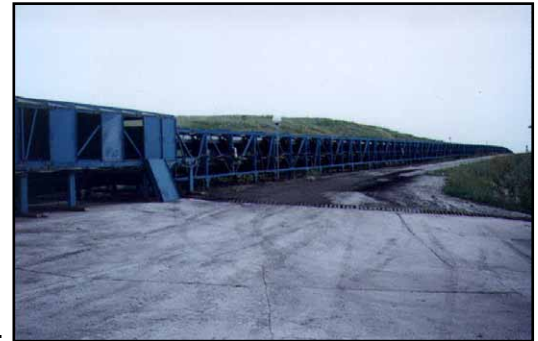
1. View of the conveyor belt facility
2. Conditioning with Belzona® 2911
3. Belzona® 2311 used to rebuild the damage

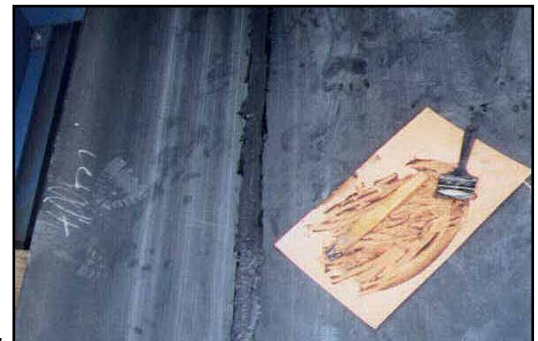
3.

Mechanical damage on the protector/scrapper was exposing the metal reinforcement

Belzona® 2311 (SR Elastomer)
