A GOOD NIGHT WITH BELZONA

Sewage manhole on the local street.

Manholes on the street were causing a lot of noise due to uneven cover seat. Local people call them "Singing Covers".

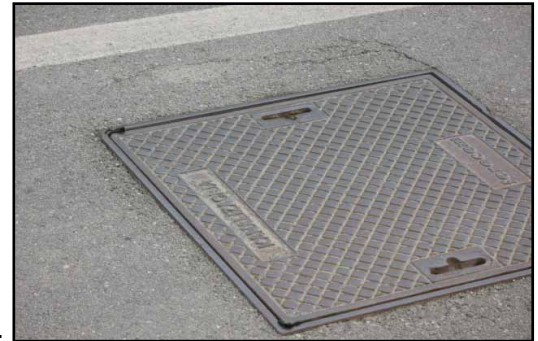
1. Manhole
2. Applying Duct tape and Belzona® 9411
3. Rebuilding manhole cover seat with Belzona® 1111
4. Manhole in place and position marked
