BELZONA PROTECTS TUBE SHEET AND TUBES

Steel mill, Slovakia

Condenser tube sheets and tubes

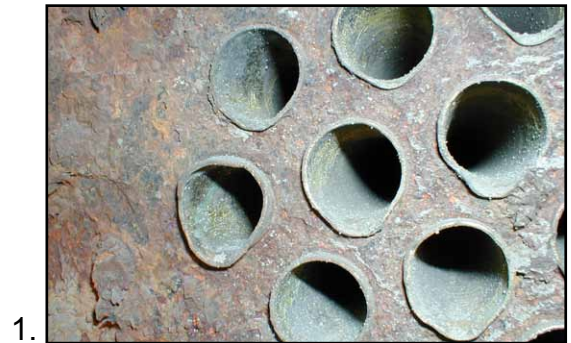
Corrosion problems were beginning on the tube sheet and inlet tubes (50 mm).

1. The corroded tube sheet
2. Sketch of the repairs
3. Loading insertions
4. Application after three years (still like the new)

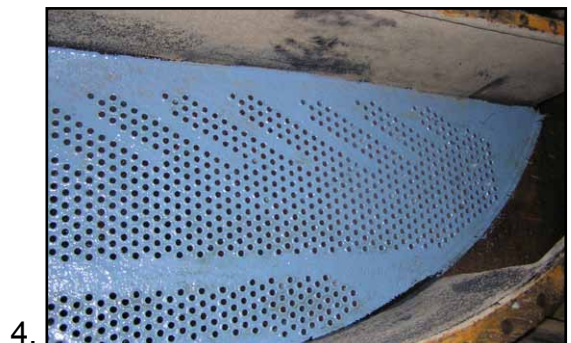
Belzona provided long term protection, increasing the life of the tube sheet and also inlet tubes, decreasing other repair and maintenance costs. Inspection after three years showed excellent protection being maintained.
