BELZONA CONTAINS SULFURIC ACID

Ethanol Plant, Iowa, USA

Sulfuric Acid containment area

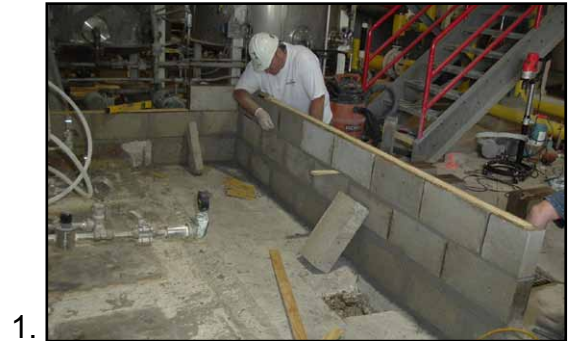
1. Concrete block being laid with Belzona® 4131 as mortar
2. Floor sloped to the drain
3. Pumps back in service
4. Completed drain

Application was carried out in accordance with modified Belzona System Leaflets TCC-9 & 15. Concrete blocks were laid using Belzona® 4131 as mortar. Floor was re-profiled and sloped so any spill would run towards the drain. The entire floor and walls were coated with Belzona® 4311.
