BELZONA REPAIR TO KING PIN BUSH HOUSING

Metal processing plant, Bulgaria

Front end loader king pin connection

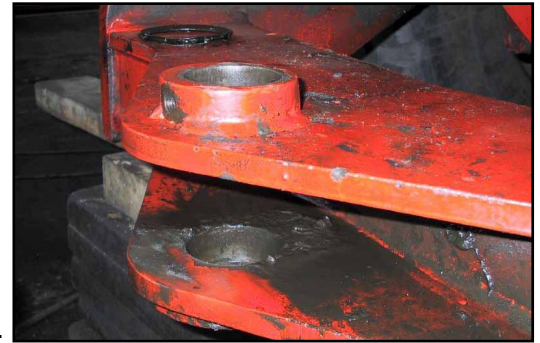
Wear of the seats leading to increased clearance

1. View of the damaged connection.
2. Belzona® 1111 applied on the prepared housing surface.
3. The pin coated with release agent was used to form the housing.
