BELZONA RELIEF VALVE REPAIR

Hydro Electric Generating Station - Scotland

August 1998

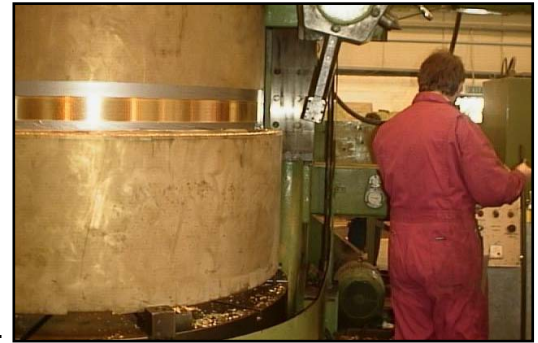
1. Piston being machined out.
2. Belzona® 1111 machined to tolerance.
3. Valve in for overhaul in 2007. This had nothing to do with the original Belzona repair.
4. Belzona in good condition and was returned to service with no work required after passing offsite hydrostatic testing and onsite commissioning.

Application was carried out in accordance with the Belzona Know-How System Leaflet MPT-1. Damaged area was machined out, filled with Belzona® 1111 then machined to tolerance.

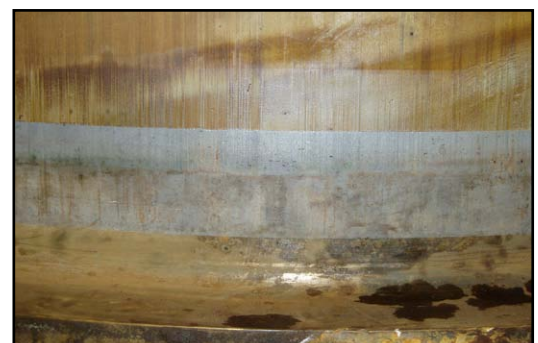
The difficulty of weld repairing similar jobs previously had led to lost time and missed deadlines. Written report received from client confirming Belzona repair in good condition and suitable for return to service after already completing 9 years service.
