## BELZONA ROOF APPLICATION STILL WATERTIGHT 20 YEARS ON

Auto manufacturer, Wentzville, MO

October 1988

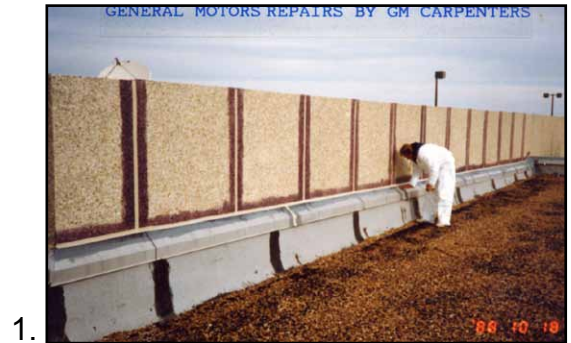
1. Belzona® 3911 being applied
2. Belzona® 3111 application
3. Follow up picture February 2008
