BELZONA REFITS CRUSHER BEARING

Limestone quarry, Silex, MO

New 12 dia. bearing had to be fitted to worn shaft on crusher"

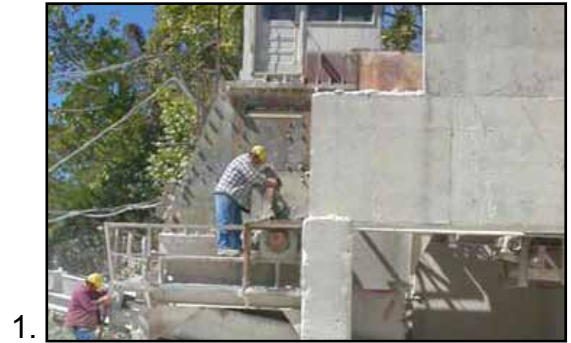
1. Overall view of the crusher
2. Damaged journal
3. Belzona® 1111 applied on the journal
4. Finished bearing refit
