BELZONA FLOOR REPAIR 24 YEARS ON

Auto manufacturer, Wentzville, MO

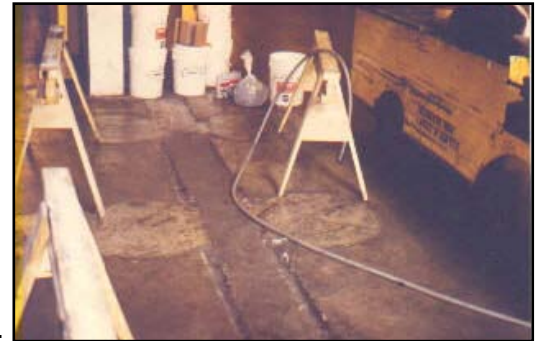
Rough area caused vehicles to lose their load, creating a safety hazard and damage to package contents. In addition, the rough ride damaged sensitive electronic equipment.

1. Original floor in 1984
2. Belzona® 4111 application completed
3. Belzona® 4111 in February 2008

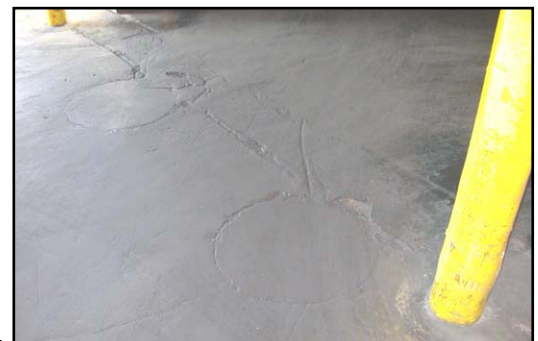
3.

Safety concerns were paramount. One single piece of damaged electronics far surpassed the cost of the entire Belzona application. After 24 years, there is some slight damage, but the floor is still performing satisfactorily.
