BELZONA KEEPS CUSTOMERS ROLLING

Plant rental company, Augusta SC

Tire repair

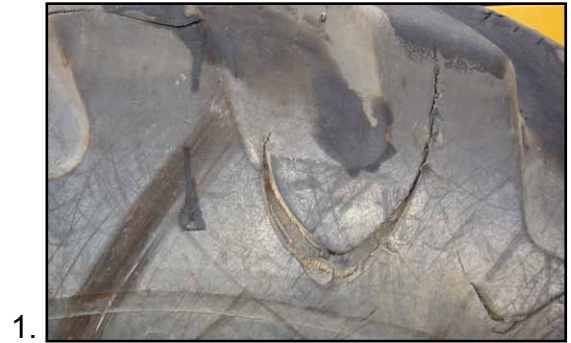
After the rental was returned they saw the damage and needed a repair right away, knowing the unit was booked to go right back out.

1. Damage to the tire
2. After the roughing surface conditioned
3. Belzona® 2311 completed repair

Application was carried out using a modified Belzona Know-How System Leaflet SHM-1. The Surface was roughed with roughing brush, Conditioned then gouges in tire repaired with the Belzona® 2311.
