## BELZONA EMERGENCY LEAK SEALING

Waste Water Utility / Oklahoma

April, 2006

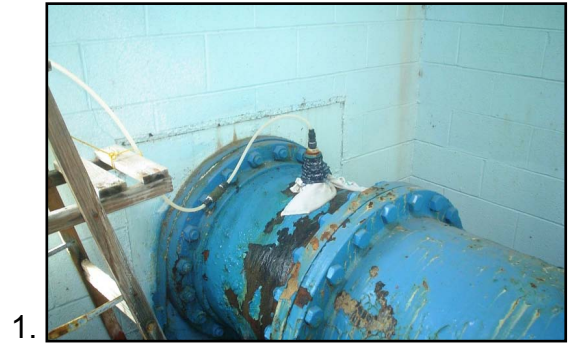
1. Rags over leak to keep the spray down
2. Sanding the leak and getting wet
3. Belzona® 1291 applied and leak stopped
4. Belzona® 1221 applied and leak fixed for good
