## BELZONA REPAIRS RBC SHAFT

Waste Water Treatment Plant, Oklahoma USA

RBC (Rotating Biological Contactor) shaft.

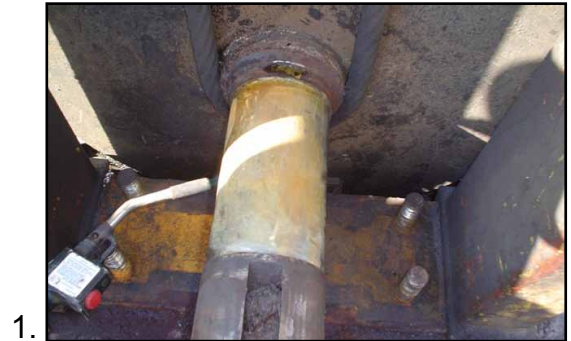
The bearing failed, damaging the shaft.

1. Damaged shaft
2. Shaft prepared and ready for Belzona
3. After curing former removed and extrusions filed down
4. The RBC is resealed and back in service
