PUMP DIFFUSER REPAIR SURPASSES ALL EXPECTATIONS WITH BELZONA

Sea water cooling system pump for a 60 MW turbine.

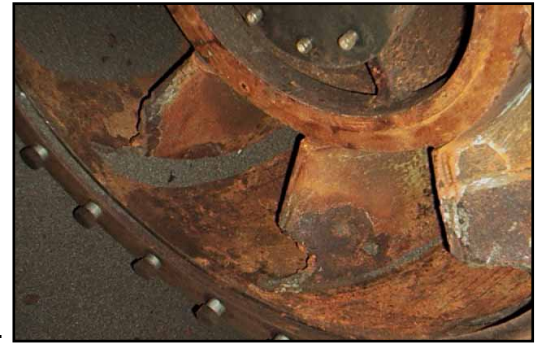
Efficiency losses and pump breakdown due to severe erosion-corrosion of the single vertical axial flow pump (7090 m³/h). Prior to the Belzona solution, the client had to replace the pump components annually. As a significant local electricity supplier, downtime of this critical equipment caused major problems.

1. Condition of the pump diffuser after 1 year in service
2. Rebuilding of the vane profiles
3. The finished application
4. Application after 9 years service

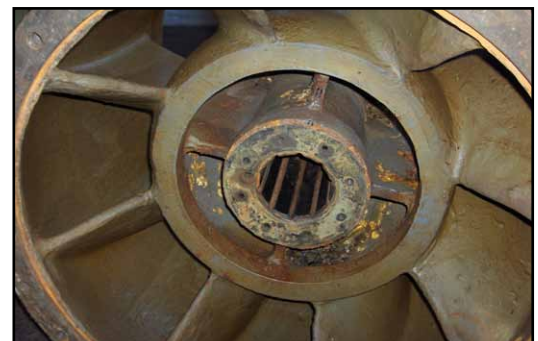
4.

The customer was surprised that the eroded equipment could be repaired and delighted with the vastly improved reliability and performance. The pump casing and suction bell were also coated and protected internally and externally. After 9 years in service, the coating was found to still be in excellent condition.
